Manhole Inspection Summary

Manhole # S25I__033MH

Insp Date: **3/12/08 10:35 AM**

Location Address: **S.CAREY ST. (NW Corner)**

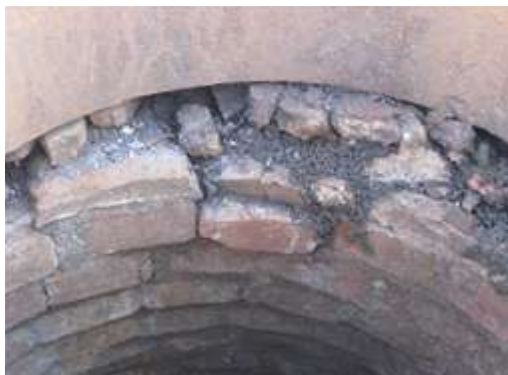
Defect 3

Condition: ☐ Sound ☐ Cracked ☐ Root Intrusion ☒ **Loose Brick** ☐ Deteriorated

Infiltration: ☐ None ☐ Joint ☐ Cracks ☒ **Mortar** ☐ Roots ☐ Wall

MISSING MORTAR AND BRICKS WITH EVIDENCE OF INFILTRATION AT CHIMNEY AND 2" OFFSET

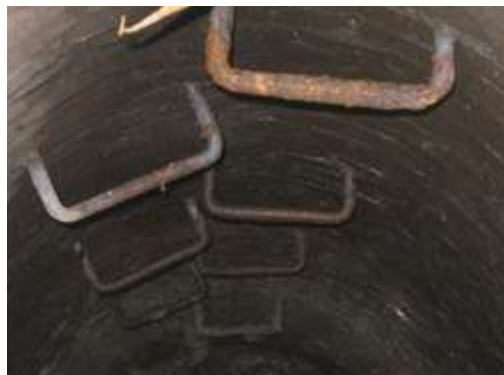
Defect 2

Count: **7** Missing: **1** ☒ **Corroded**

☒ **Evidence Of Surcharge** Depth: **2** (ft.) ☐ Active Surcharge Present

CORRODED STEPS (1 BROKEN) WITH EVIDENCE OF SURCHARGE AND EVIDENCE OF INFILTRATION AT

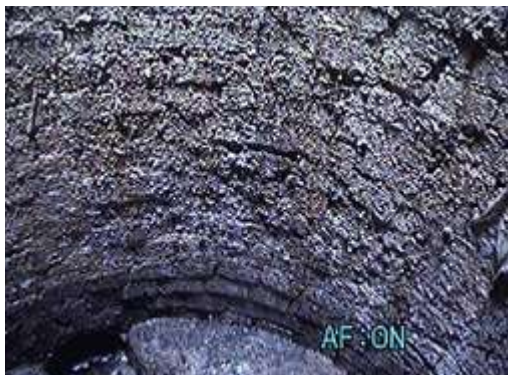
Defect 1

Infiltration: ☐ None ☐ Joint ☐ Cracks ☐ Mortar ☐ Roots ☒ **Wall**

ACTIVE INFILTRATION AT THE BARREL

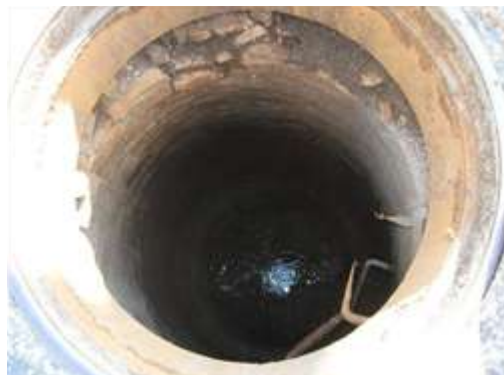
Defect 4

Condition: ☐ Sound ☐ Cracked ☐ Root Intrusion ☒ **Deteriorated** ☐ Leaks ☐ Debris

Condition: ☐ Sound ☐ Cracked ☐ Root Intrusion ☐ Deteriorated ☐ Leaks ☒ **Debris**

Bench and Channel Debris, offset

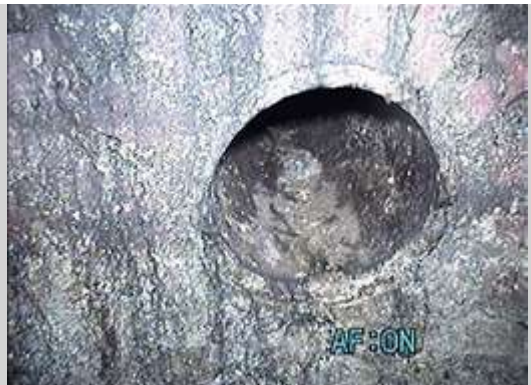
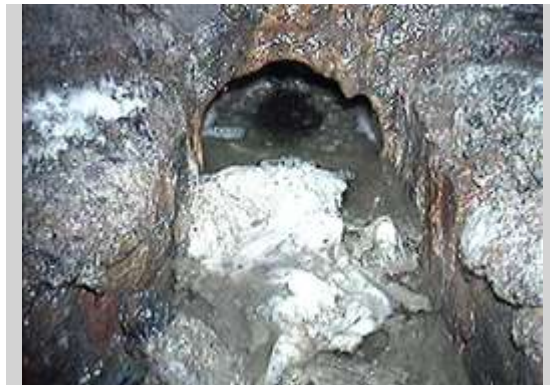
3 O'Clock Inflow

Drop: **Outside** Rod and Bar
Angled: **Yes** Reading: **13.02** (ft.)
Inv Depth: **14.02** (ft.)
Drop Condition: **Partly Clogged**

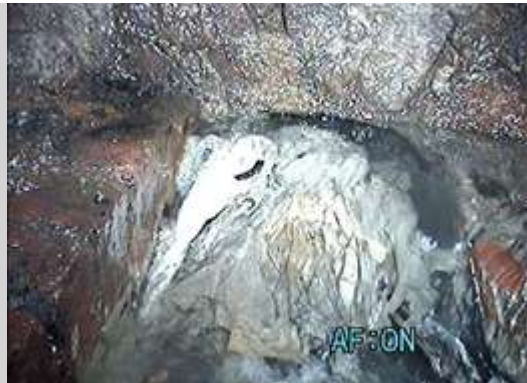
9 O'Clock Inflow

Deposits: ☐ None ☐ Mud ☐ Sludge ☒ **Debris** ☐ Grease

Silt Depth: **7** (in.) Deposits Extent: **Heavy**
